linea 3016

TEXTURE, TYPE & COLOUR

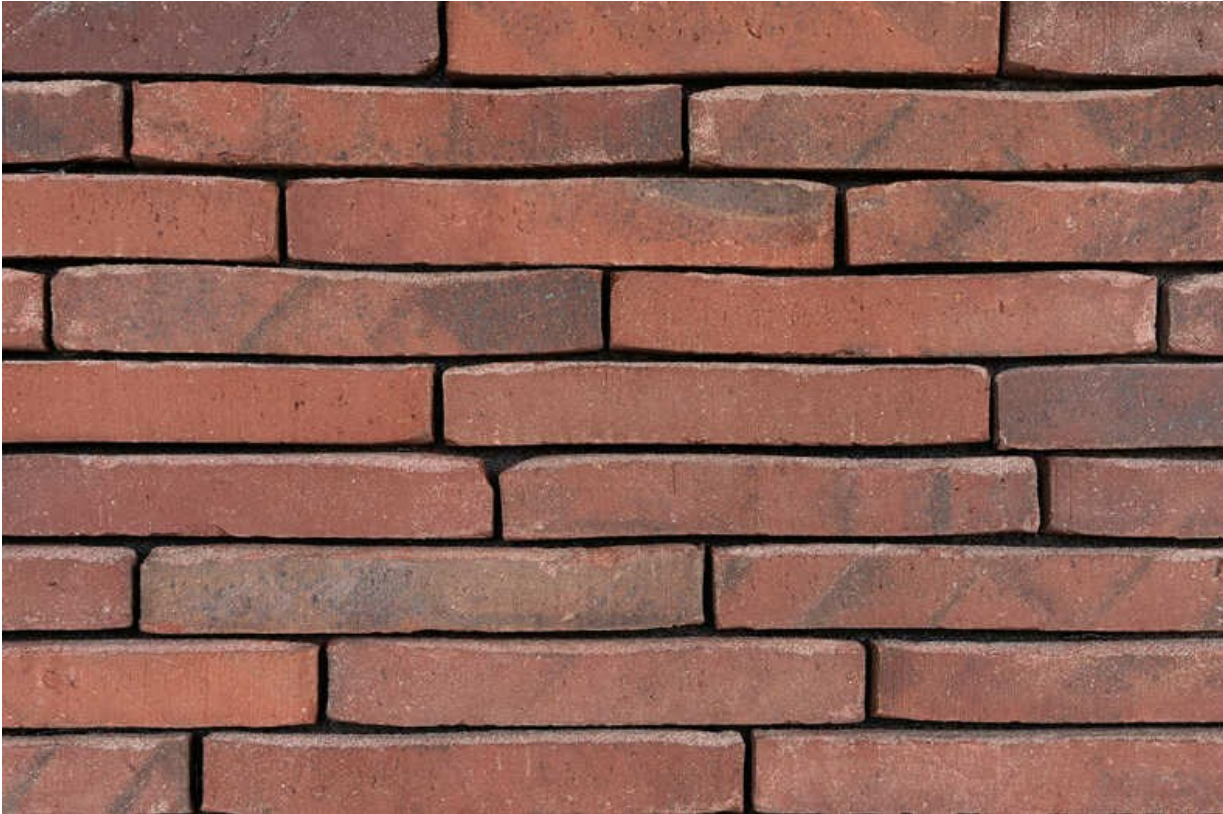
Productshot

The decorative brickwork (inside and/or outside face) is made with a solid unsanded moulded brick without grain with a very uneven structure. Due to the natural reduction with coal the bricks have a strong fired rough field fire aspect. Some visible sides of the brick also contain traces of coal and of the manual production method. The colour of the body is coral to brown-red with nuances.
