linea 6012

VANDE MOORTELT
CLAY PAVERS • FACING BRICKS • SLIP

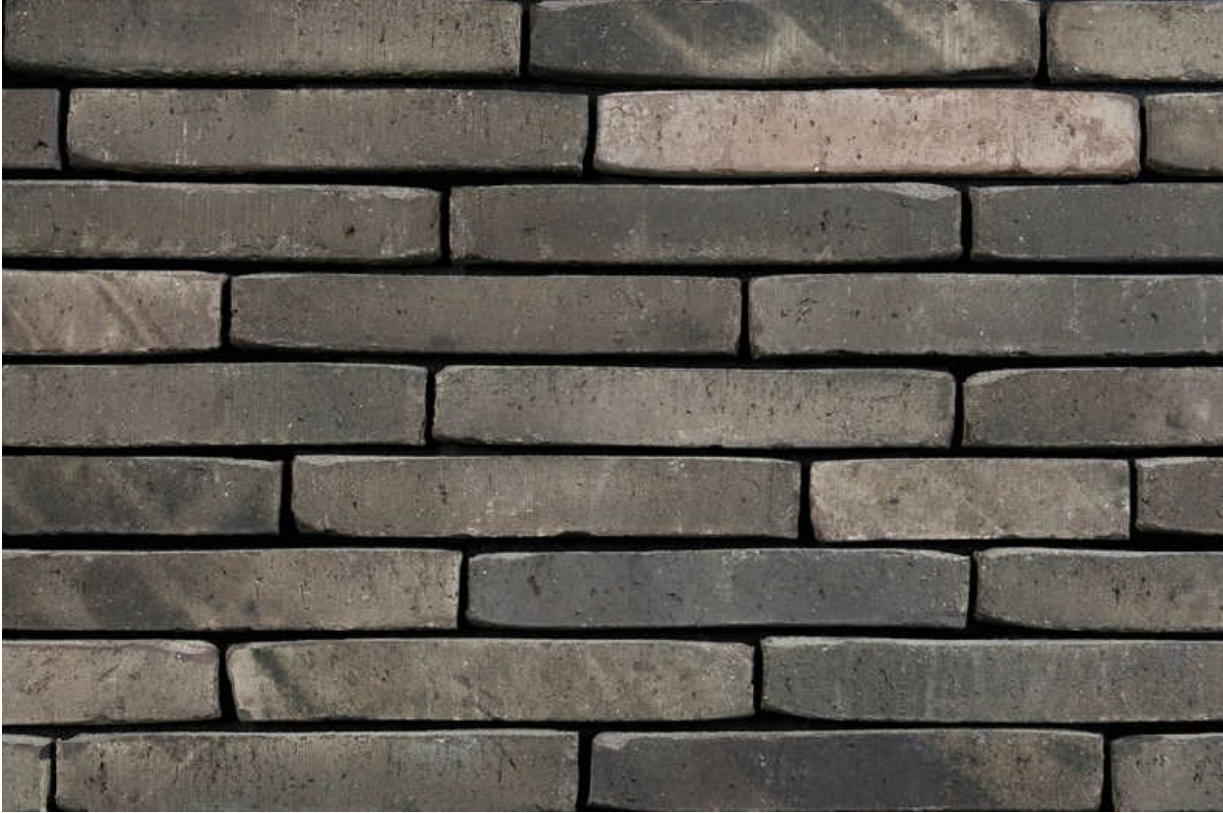
Productshot

The decorative brickwork (inside and/or outside face) is made with a solid unsanded moulded brick without grain with a very uneven structure. Due to the natural reduction with coal the bricks have a strong fired rough field fire aspect. Some visible sides of the brick also contain traces of coal and of the manual production method. The colour of the body is grey-green-brown to black-green with nuances.
