## linea 6012

# linea 6012

FACING BRICKS  
CATEGORY I, U

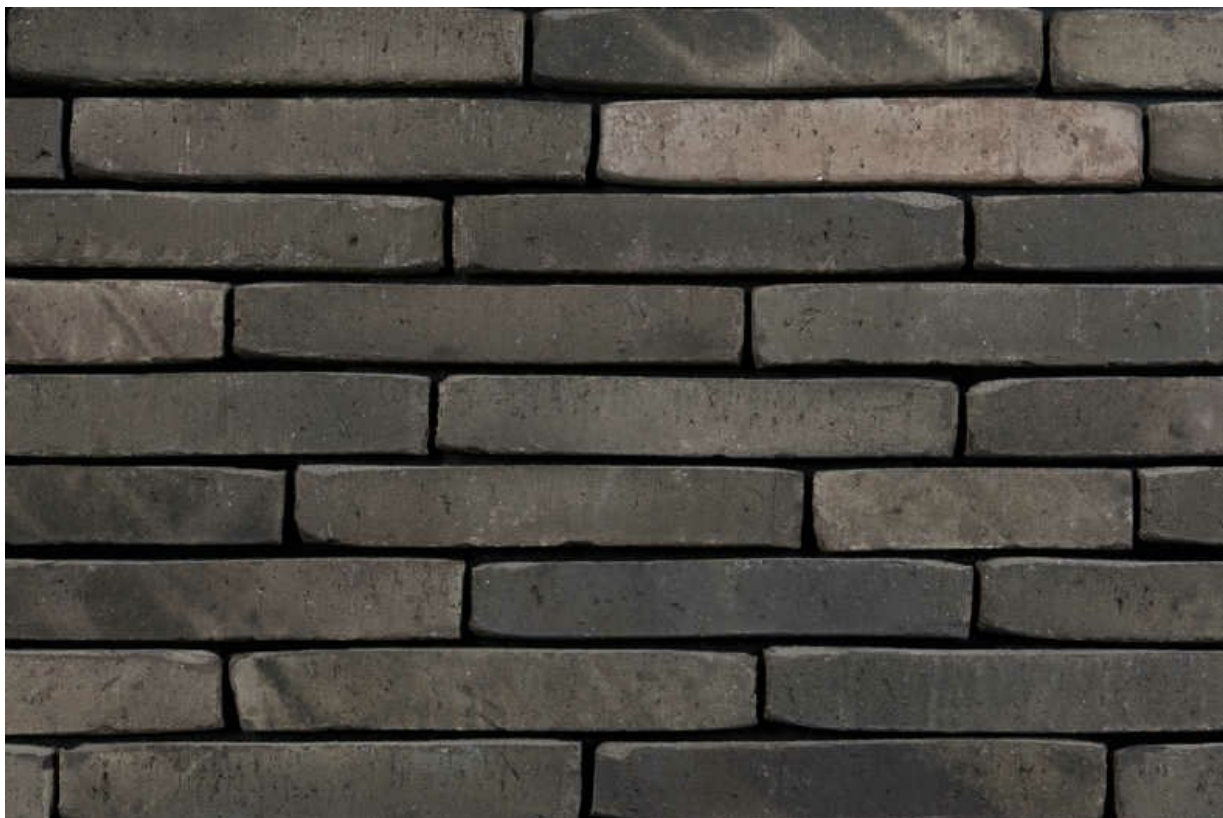
## Productshot

The decorative brickwork (inside and/or outside face) is made with a solid unsanded moulded brick without grain with a very uneven structure. Due to the natural reduction with coal the bricks have a strong fired rough field fire aspect. Some visible sides of the brick also contain traces of coal and of the manual production method. The colour of the body is grey-green-brown to black-green with nuances.
