# linea 7035

FACING BRICKS  
CATEGORY I, U

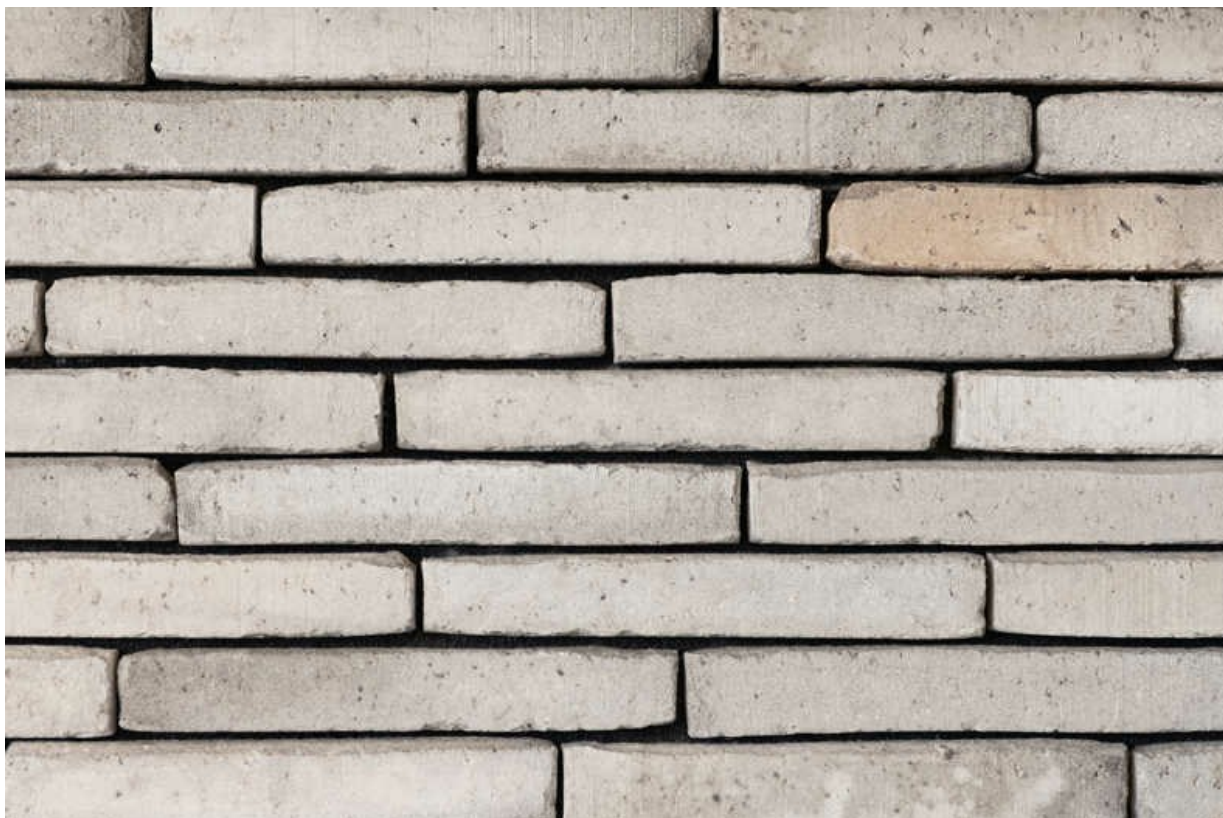
## Productshot

The decorative brickwork (inside and/or outside face) is made with a solid unsanded moulded brick without grain with a very uneven structure. Due to the natural reduction with coal the bricks have a strong fired rough field fire aspect. Some visible sides of the brick also contain traces of coal and of the manual production method. The colour is light grey with nuances through and through and with beige accents..
