linea 9001

FACING BRICKS
CATEGORY I, U

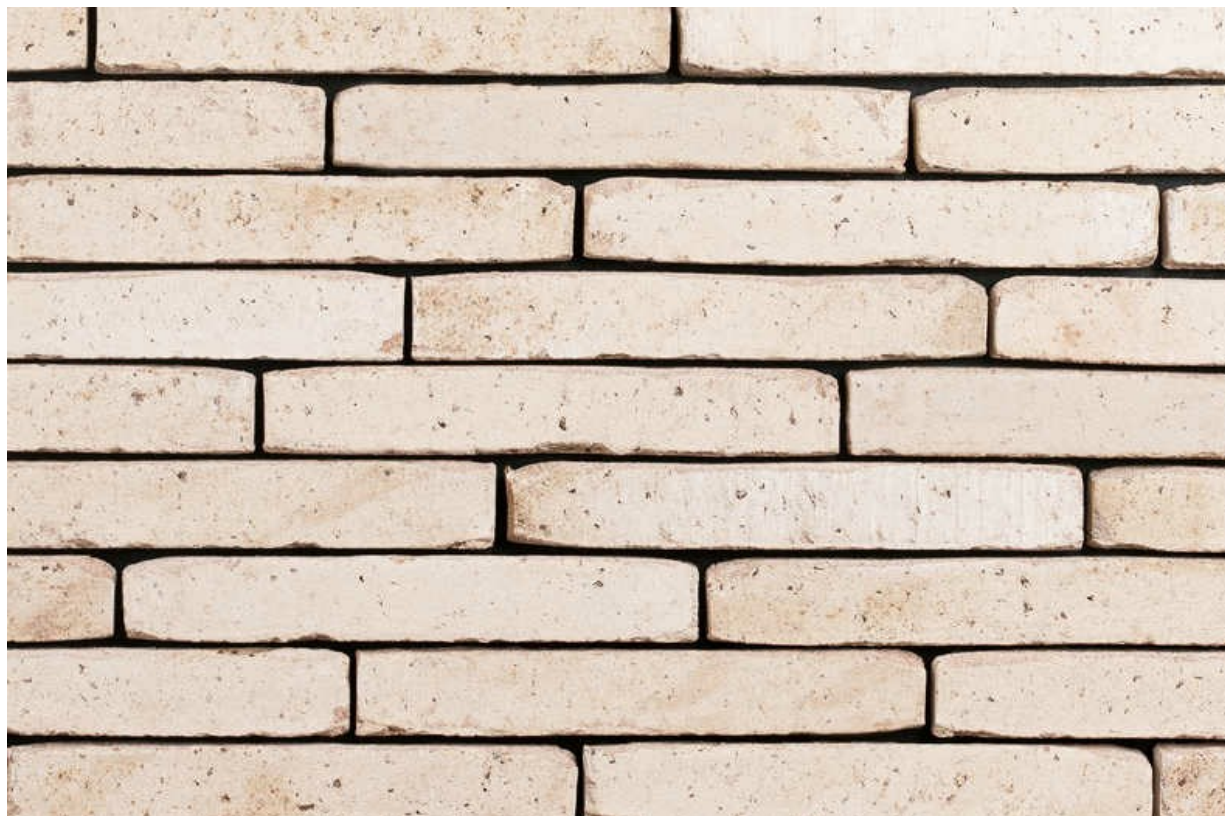
Productshot

The decorative brickwork (inside and/or outside face) is made with a solid unsanded moulded brick without grain with a very uneven structure. Due to the natural reduction with coal the bricks have a strong fired rough field fire aspect. Some visible sides of the brick also contain traces of coal and of the manual production method. The colour is ecru to cream-white with nuances through and through.
