linea 9001

TEXTURE, TYPE & COLOUR

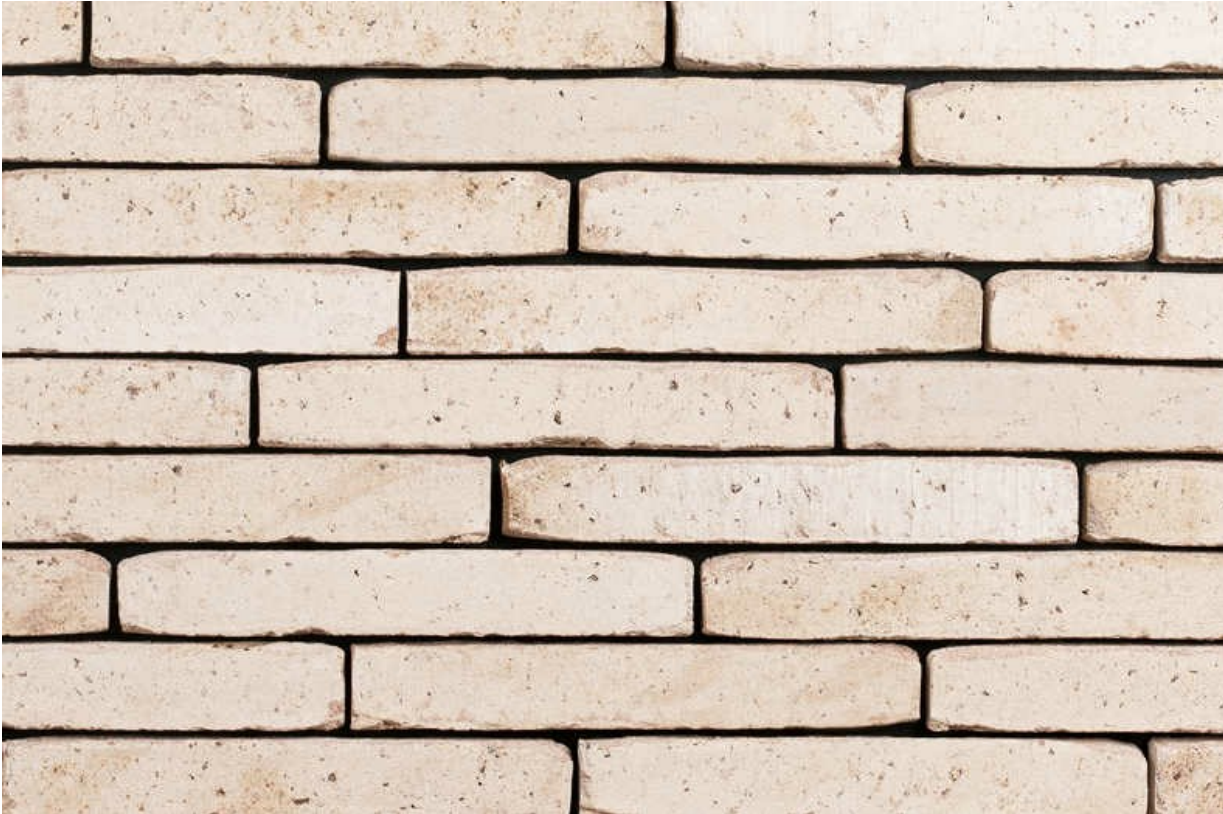
Productshot

The decorative brickwork (inside and/or outside face) is made with a solid unsanded moulded brick without grain with a very uneven structure. Due to the natural reduction with coal the bricks have a strong fired rough field fire aspect. Some visible sides of the brick also contain traces of coal and of the manual production method. The colour is ecru to cream-white with nuances through and through.
