N10 Brick E

TEXTURE, TYPE & COLOUR

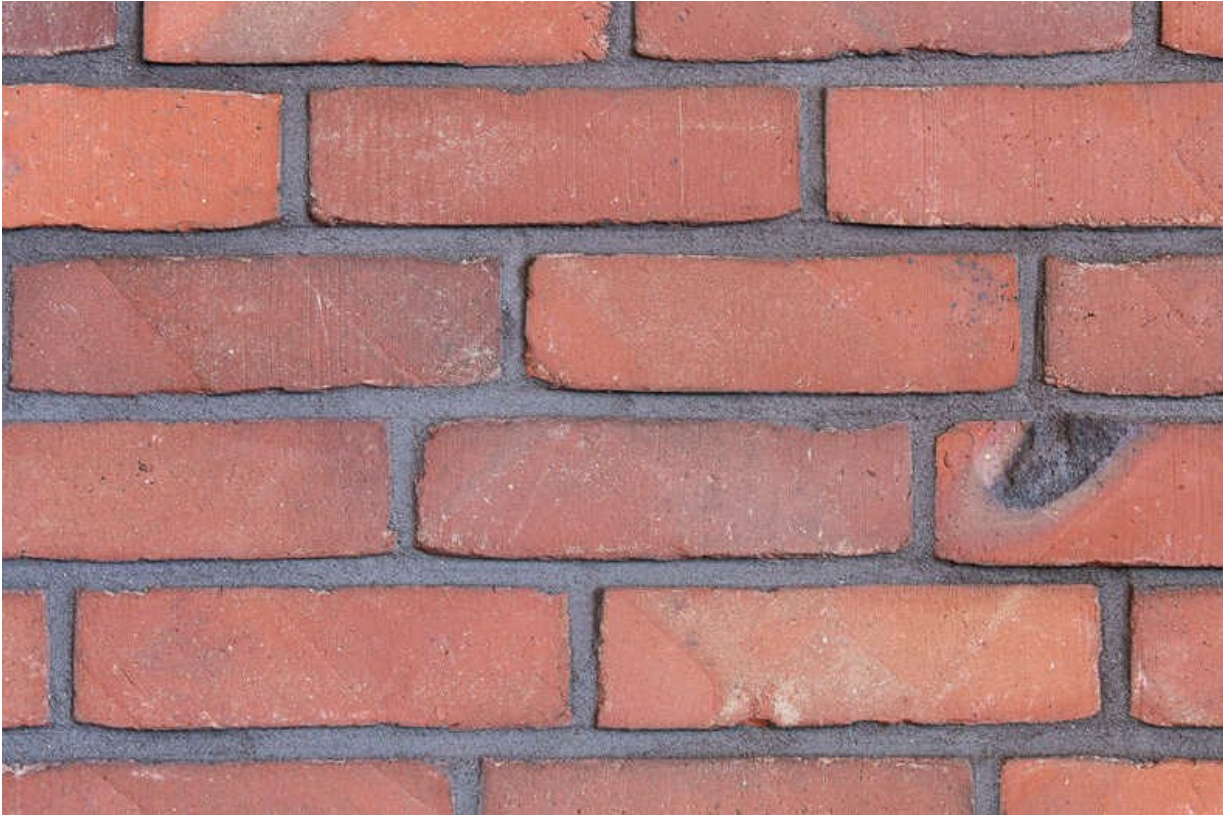
Productshot

The decorative brickwork (inside and/or outside face) is made with a solid unsanded moulded brick without grain with a very uneven structure. Due to the natural reduction with coal the bricks have a strong fired rough field fire aspect. Some visible sides of the brick also contain traces of coal and of the manual production method. The colour of the body is red with strong red and red-brown to purple-blue nuances.
