© copyright Vande Moortel NV Technical Sheet / Tender Book

FACING BRICKS CATEGORY I, U

11-08-2025

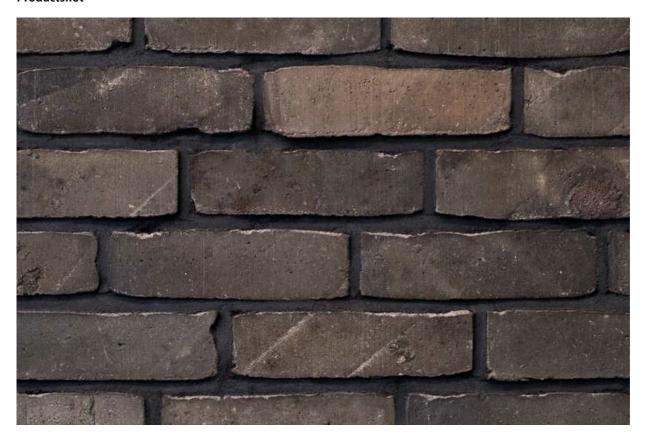
Productshot

The decorative brickwork (inside and/or outside face) is made with a solid unsanded moulded brick without grain with a very uneven structure. Due to the natural reduction with coal the bricks have a strong fired rough field fire aspect. Some visible sides of the brick also contain traces of coal and of the manual production method. The colour of the body is bordeaux-brown-grey and it has strong nuances ranging from grey-brown to black-brown with light green-grey accents.

N10 Brick S
