### TEXTURE, TYPE & COLOUR

### RAW MATERIAL & PRODUCTION & VIEWS

# Brick J

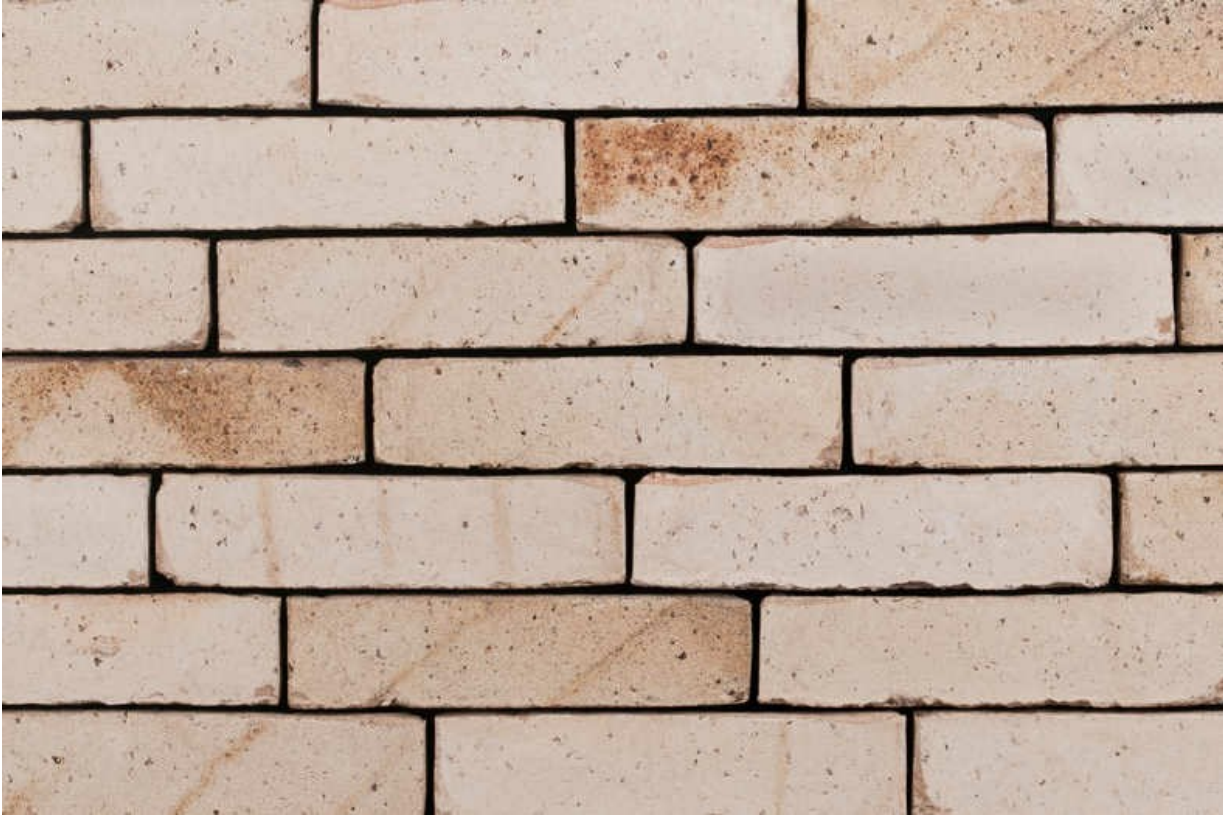
## Productshot

The decorative brickwork (inside and/or outside face) is made with a solid unsanded moulded brick without grain with a very uneven structure. Due to the natural reduction with coal the bricks have a strong fired rough field fire aspect. Some visible sides of the brick also contain traces of coal and of the manual production method. The colour of the body is cream and nuanced from cream to ecru.
